JOB SITE: 10613 NE 38<sup>th</sup> Place, Kirkland, WA 98033

SUBJECT: Tree Inventory & Viability Assessment - Report Addendum

DATE: October 14, 2014

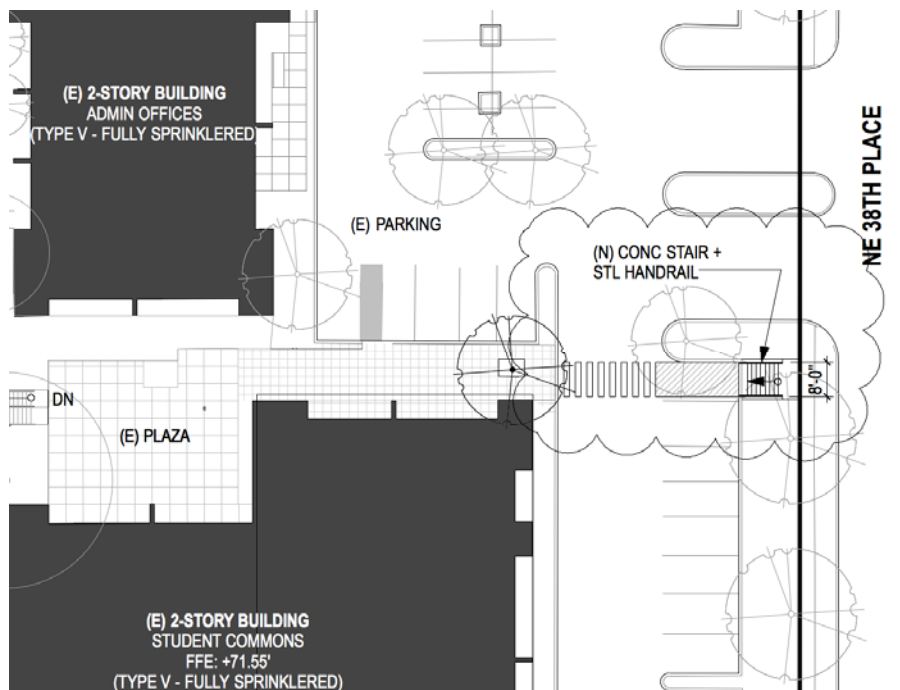
The design review board required an access stairway be installed from NE 38th Pl into the parking lot through the root zone of several protected trees. The architect has come up with a solution of installing a 5' wide steel stair atop piers. We agree that this plan will allow the stairs to be built with minimal impact to the root zone of the trees and will allow them to be retained in good condition.
